Photocatalytic Degradation of NOx - SELF CLEANING Surface

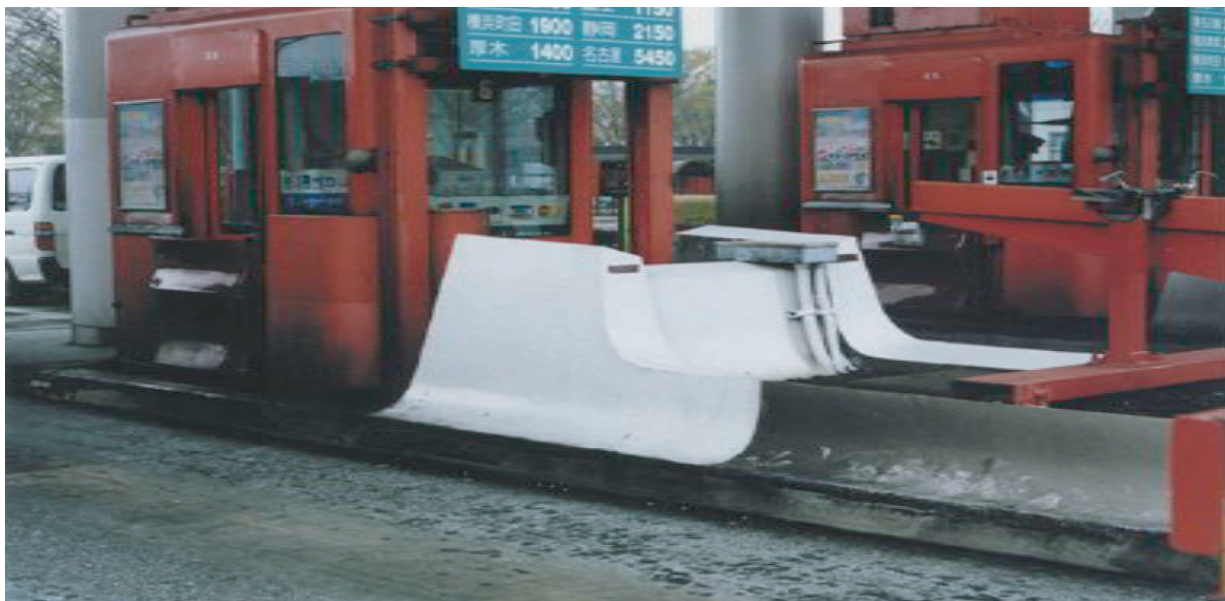
This photo is taken in 2005 at a toll booth in Japan. Six months after the applicaiotn of our TPXsol photocatalyst Coating.This clearly demostrates the grime preventing functionality of our photocatalytic coating.

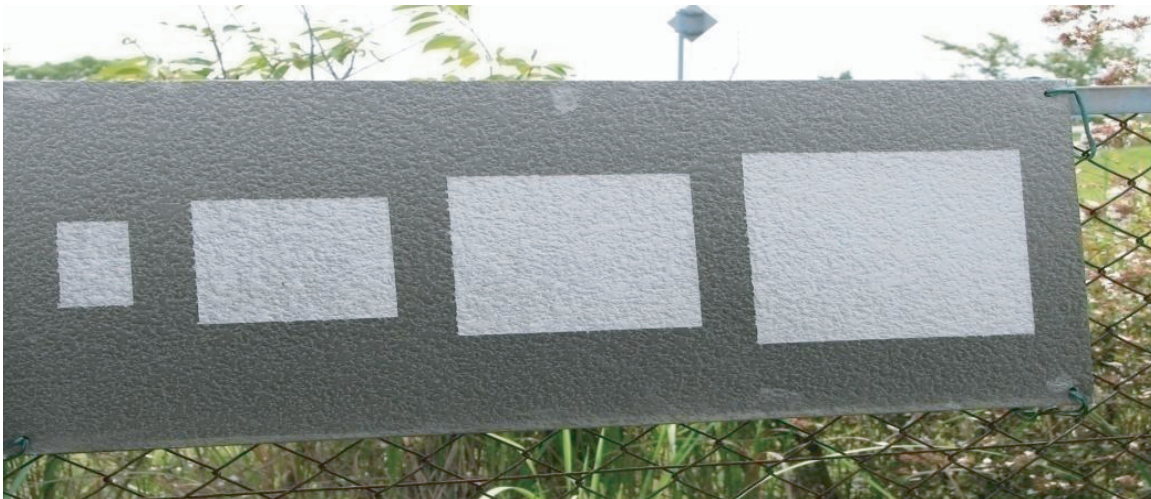
This photo shows a white concrete panel exposed to six months of highway grime. The white squares had been coated with our TPXsol phocatalyst self cleaning coating.
